Manhole Inspection Summary

Manhole # S49MM_009MH

Record Plat: **49MM** Node: **009** Status: **Found**

Location Address: **Belair rd**

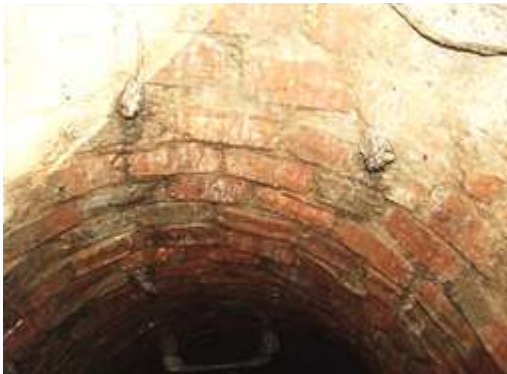
Defect 5

steps

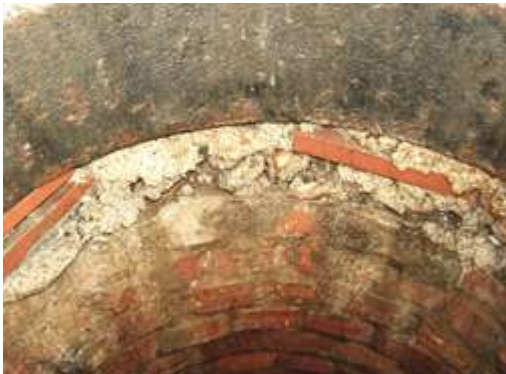
Defect 4

Condition: ☐ Sound ☐ Cracked ☐ Root Intrusion ☒ **Loose Brick** ☐ Deteriorated

loose bricks

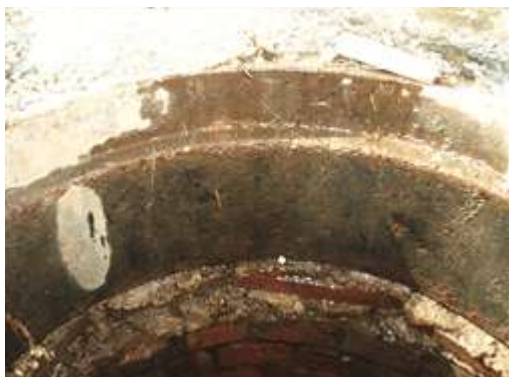
Defect 3

frame leaks

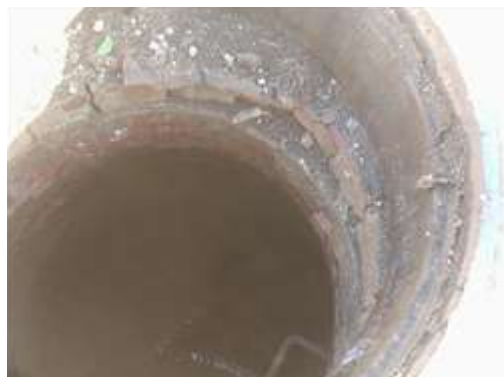
Defect 1

loose bricks

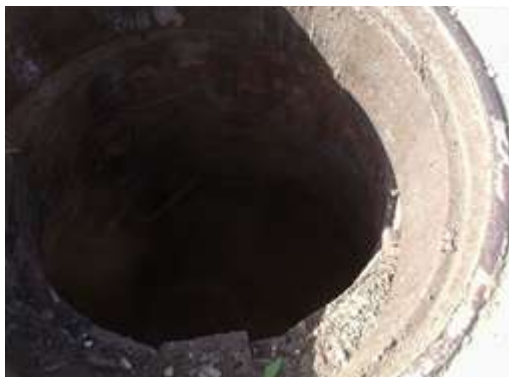
Defect 2

Infiltration: ☐ None ☒ **Joint** ☐ Cracks ☒ **Mortar** ☐ Roots ☐ Wall

infiltration

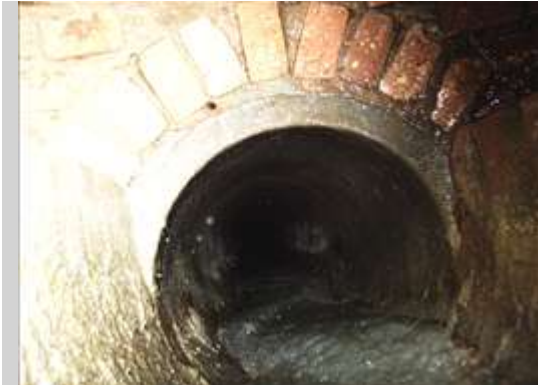
8 in. Circular Gravity Sewer
Pipe Out @ 12 O'Clock

Pipe Height: **8.4** (in.) Rod and Bar (Angled)
Pipe Material: **Clay** ☐ Pipe Lined
Invert Depth: **9.00** (ft.) Flow Characteristics: **Fast**
Deposits: ☒ None ☐ Mud ☐ Sludge ☐ Debris ☐ Grease
Silt Depth: (in.) Deposits Extent:
Infiltration: **None** Pipe Seal Cond: **Sound**

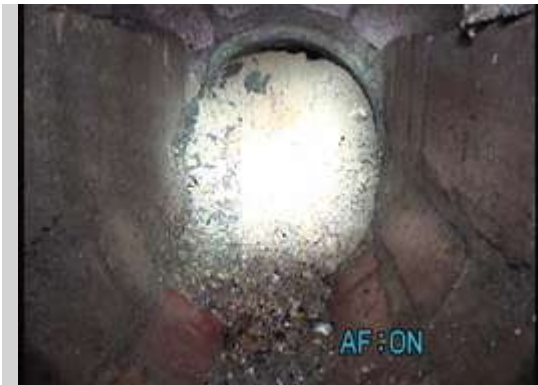
8 in. Circular Gravity Sewer
Pipe In @ 6 O'Clock

Pipe Height: **8.4** (in.) Rod and Bar (Angled)
Pipe Material: **Clay** ☐ Pipe Lined
Invert Depth: **8.80** (ft.) Flow Characteristics: **None**
Deposits: ☒ None ☐ Mud ☐ Sludge ☐ Debris ☐ Grease
Silt Depth: (in.) Deposits Extent:
Infiltration: **None** Pipe Seal Cond: **Sound**

Connects To: **Stub connection / abandoned**

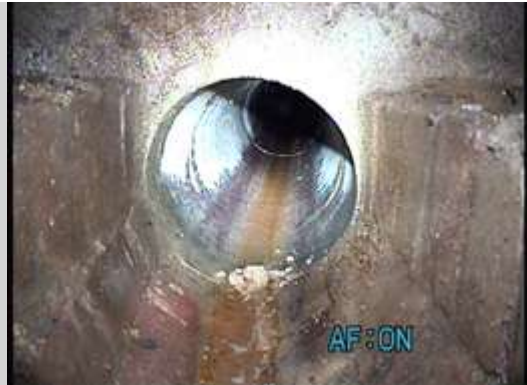
Pipe In @ 8 O'Clock

Pipe Height: **8.4** (in.) Rod and Bar (Angled)

Pipe Material: **Clay** ☐ Pipe Lined

Invert Depth: **8.70** (ft.) Flow Characteristics: **Fast**

Infiltration: **None** Pipe Seal Cond: **Sound**
